Tek2712 repair

January 2015, Koos Bouwknecht

Since 2009, I have a Tek2712 spectrum analyser, made in 1994 by Tektronix Beaverton. The analyser was used incidentally the first 15 years without problems.

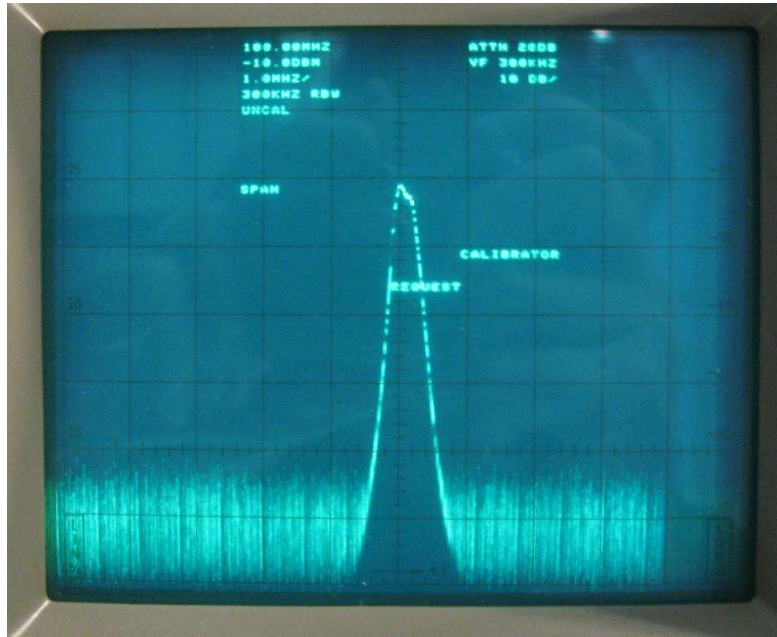
When I got the analyser, the first problem was a gradually shrinking of the display, including the on-screen display (OSD). The display in direct view mode (non storage, button "D" pushed) was normal, so it was not the CRT or HV supply.

The OSD data did shrink to half the normal size in this mixed display. The size reduction fluctuates between 20 and 80% of the normal size.

The problem is in the display storage board A9. This board did not correspond with the 2712 service manual (1992?) but was the A9 board as in the service manual of the Tek2715.

The problem was clear: the reference (VR=5V) which is the only component in common for both the X and Y DAC at the output of the display storage board was too low and fluctuated.

After replacing several components, the culprit was a leaky elco near 0.1uF SMD capacitor (C9) across the reference IC. The fluid caused between 200 ohm and 2k leakage. Troubleshooting was hard without an extenderboard at that time.

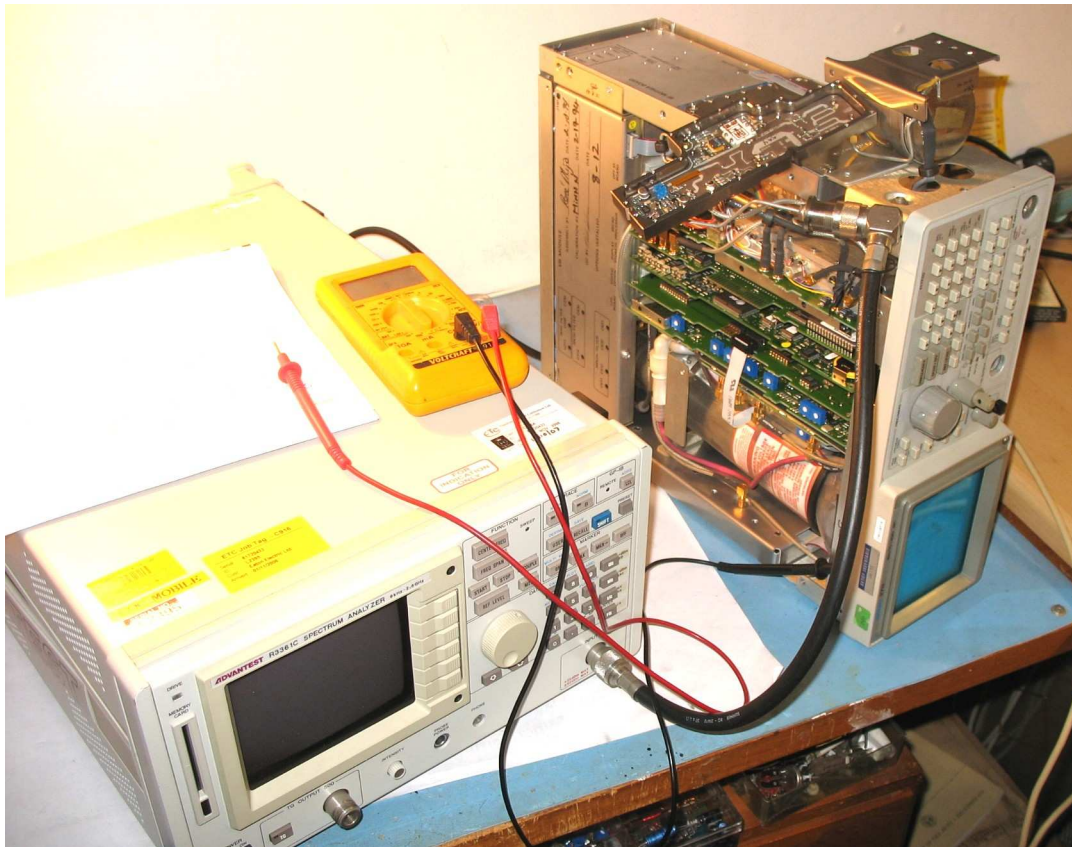
So I dismantled about any RF module and opened the LO buffer module. See the picture below. The input of the buffer module is still connected to the YIG oscillator, hanging on the right side outboard. The LO buffer stage is still powered by its flat cable from the Tek2712 mainframe.

The buffer is a single stage GaasFet, with stabilized output power. Stabilisation is done by rectifying the RF output, an opamp compares this with a blue potmeter reference. The opamp drives the drain voltage of the Gaas FET via a transistor.

Both opamp inputs and the opamp output are at -7V, so the transistor was off, and the FET got no drain voltage, explaining the very low output of the buffer stage. Connecting the drain to +8V via 100 ohm produced the normal +13 dBm RF output, so the FET itself was OK.

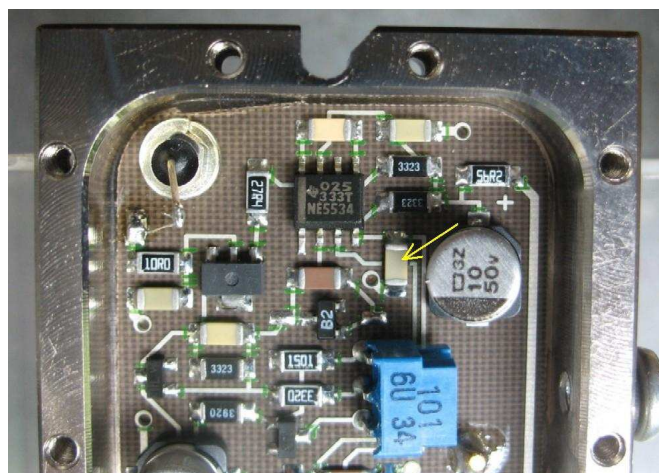
The culprit was another leaking electrolytic cap, the fluid creeps under the blue pot and the 0.1uF smd capacitor (C 292) (see yellow arrow). This track went to the plus input of the opamp, pulling the + input to -7V, and the - input to -6.6V via a diode.

I hope the detector diode is not damaged by the 7V reverse voltage. This type of schottky diodes has a maximum reverse voltage of 4V, but there are no signs even after 2 years, only a higher 0Hz peak.

After cleaning, reassembling and adjusting the LO level to +13 dBm (with the blue pot), everything was OK.

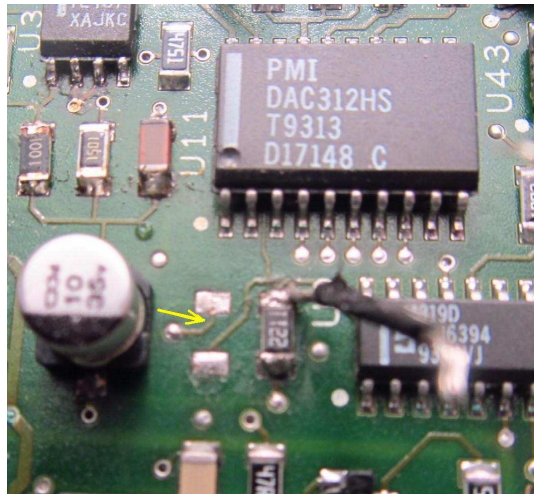
The third problem came as a horizontal jittering of the actual curve. The OSD was normal, yesterday's stored curves were normal, and the direct curve was OK as well. It seemed that the actual curve which should be written in addresses 0 to 512 of the display storage was only written in addresses approx. 100 thru 400.

The jitter was rather symmetrical, looking more as a gain error than an offset error. This could be the reference part of the DAC, the value of the 1.25k resistor, or some noise source that made extra up/down pulses to the counter.

There were no signs of excessive noise on the up/down signals. Remains the 1.25k resistor, made of a 1k smd resistor in series with a 500 ohm potmeter for Horizontal Input Gain (HIG).

After removal of the 1k resistor, a nearly interrupted trace showed up beneath it (yellow arrow) that had 200 ohm to 10kOhm resistance ! The trace was probably corroded away by the nearby leaking electrolytic capacitor (elco). After bypassing this tiny trace, everything was normal.

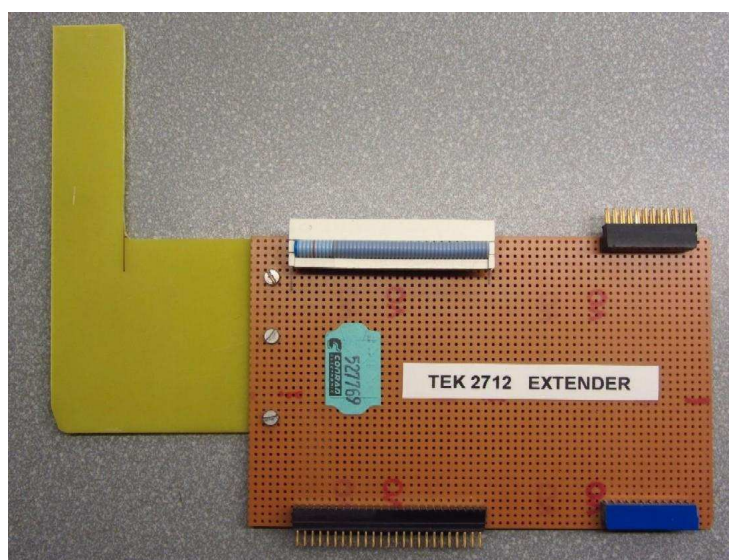
These faults could only be found with an extended display storage board. With connectors and flat cable from the junk box, I made a very useful extender.

The 50-pole flat cable and connectors are quite common, but the 24-pole connectors for the power supply lines is not. I have cut these from long connectors.

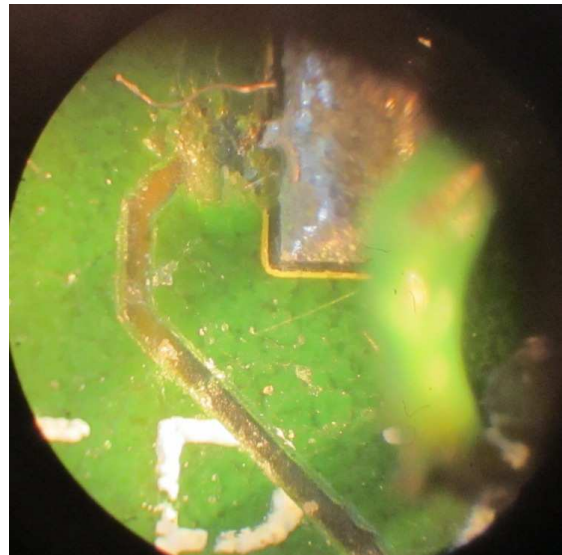
1) No trace visible, OSD and stored traces are OK. The reason was that the opamp preceding the ADC in front of the storage bank got no -11V. One pad of the 47 ohm resistor R8 was no longer connected to the -11A bus.

2) Random vertical jumps of trace and OSD was the second problem. These jumps appeared also on the -VR bus. The culprit was similar: One pad of the 47 ohm resistor R101 was no longer connected to the -11A bus.

The common problem seems to be a tiny misalignment between a solder pad and the solder mask. The mask protects the trace from corroding by acid from a nearby leaky electrolytic capacitor. But the connection of the trace to the solderpad is unprotected, and corroded until full interruption. See the microscope photo .
